Future openings

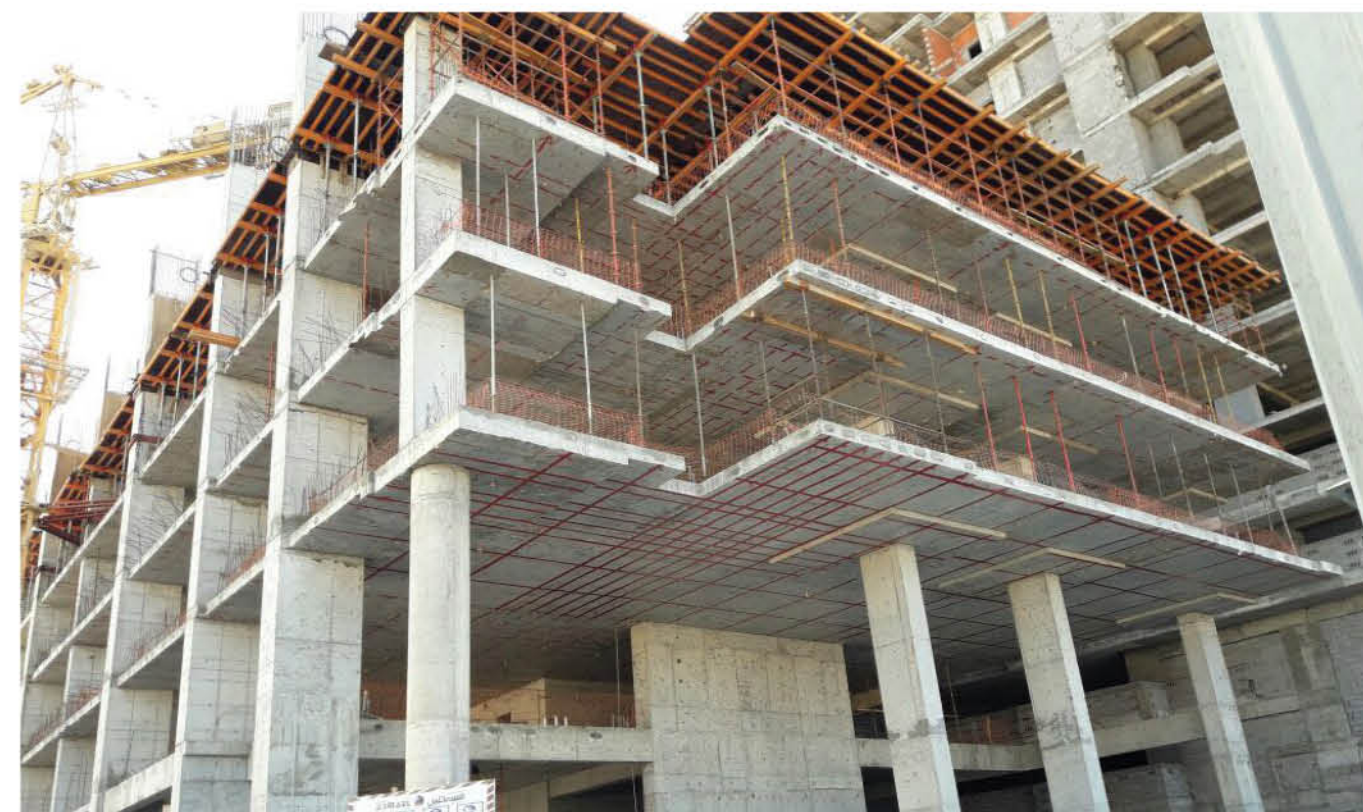
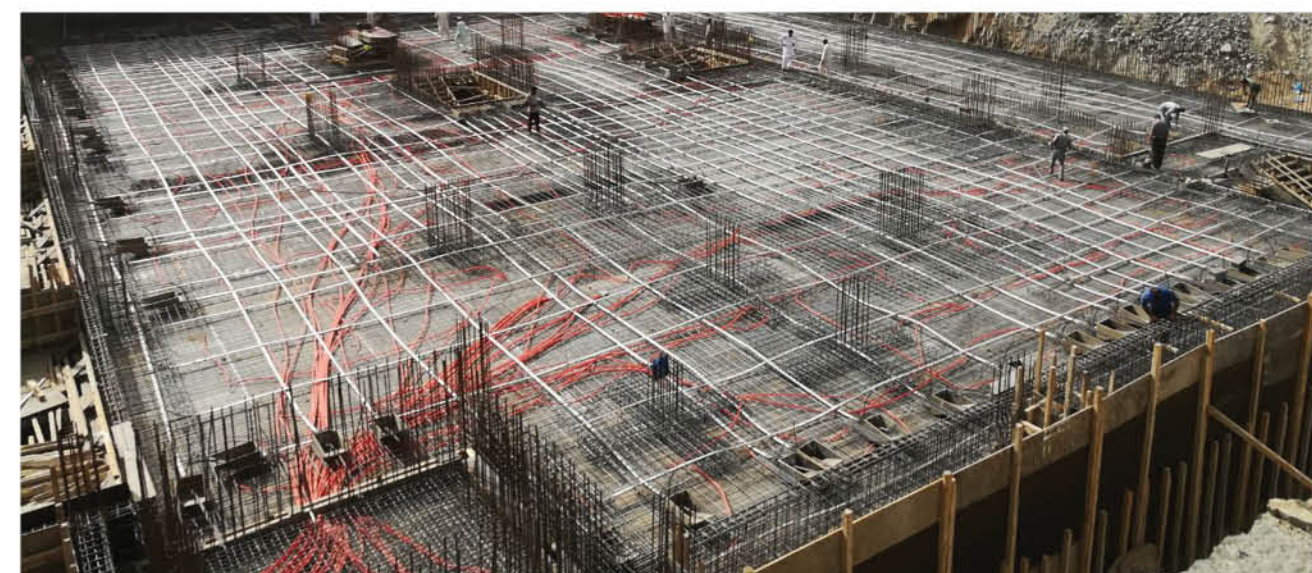
This can be achieved by using two open throat jacks back to back. After cutting the strand the force can be gently released by closing the jacks.

When the edge of the slab is re-concreted new anchors are cast in to enable the remaining lengths of tendon to be Prestressed, thus restoring full structural integrity. The above operations are not difficult but will require the expertise of a post-tensioning sub-contractor.
